Property Address 1234 School House Road
City Redmond **State** OR **Zip** 97756
Contact Name Emma Goodagent
Phone (541)-111-1111 **Fax** (541)-111-1111

Inspector Name Lee Boutell
Company Name Boutell Home Inspections
Company Address P.O. Box 22
City Madras **State** OR **Zip** 97741
Phone 541-475-4510 **Fax**
E-Mail boutell@q.com
File Number 22222
Amount Received \$300.00

Others Present Buyer's Agent and Buyer **Property Occupied** Occupied
Estimated Age 15 **Entrance Faces** Northwest
Inspection Date 4/15/07
Start Time 10:00am **End Time** 1:00pm
Electric On Yes No Not Applicable
Gas/Oil On Yes No Not Applicable
Water On Yes No Not Applicable
Temperature 70 degrees
Weather Partly cloudy **Soil Conditions** Dry
Space Below Grade Basement
Building Type Single family **Garage** Detached
Sewage Disposal City **How Verified** Visual **Inspection**
Water Source City **How Verified** Visual **Inspection**
Additions/Modifications None

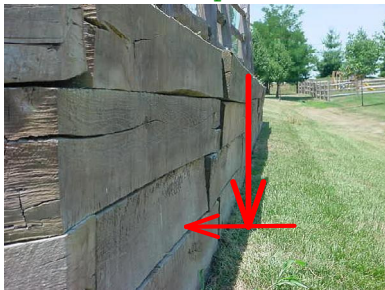
| 8. | <input type="checkbox"/> | <input type="checkbox"/> | <input type="checkbox"/> | <input checked="" type="checkbox"/> | <input type="checkbox"/> | <input type="checkbox"/> | Retaining Walls: Railroad ties --The wall is showing signs of movement, but appears to be stable at this time. A qualified contractor is recommended to evaluate and estimate repairs to maintain the wall. |

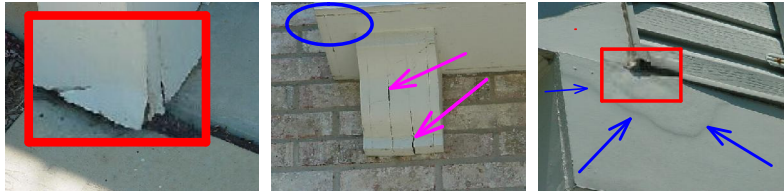
1. Water damage to trim wood at either side of garage door from moisture wicking into the finished particle board. The surface is starting to delaminate. Recommend repair/replacement of trim boards.

2. The wood window boxes have water damage and will require repair/replacement. The wood has started to separate at the supports and at the corners of the window boxes.

3. The trim board at the southwest corner of the porch has water damage due to water penetration and will require repair/replacement of the wood. The trim board extends out creating a ledge allowing water to collect on the top edge of the board and cause the wood to rot.

Recommend estimate/repairs by a qualified contractor.
